1. Yarra Park – Tree Management

2. Overview of existing trees

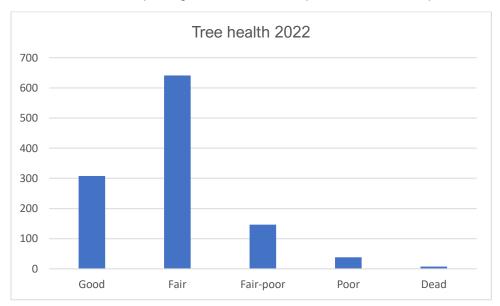
Eighty-three percent of the tree population displayed fair (considered typical of the species) or better health. The high health rating could be attributable to the increase in irrigation over the last decade and a reduction in car parking, which reduces the potential for soil compaction.

Figure 1. Health ratings of the assessed trees. Most trees are in fair or better health.

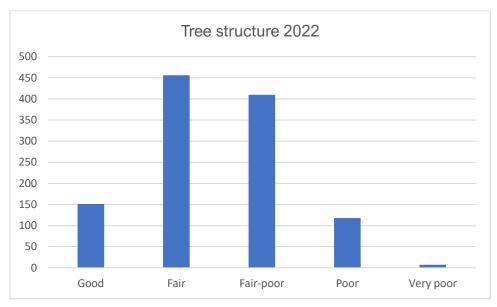
Whereas approximately 47% of the tree population displayed fair to poor or worse structure (comprising various structural deficiencies). A healthy tree is not necessarily a structurally sound one. With the best of intentions at the time, in hindsight, many of the elms have received poor pruning practices which has resulted in large wounds and decay and regrowth that is poorly attached.

Figure 2. Structure ratings of the assessed trees. There is a higher percentage trees with some form of structural deficiency.

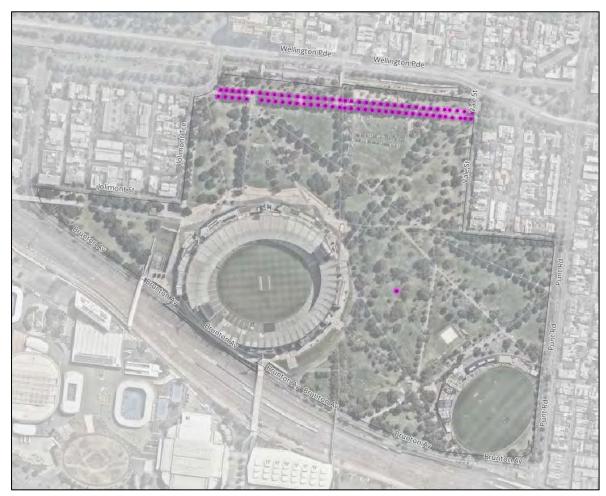
The site is covered by the Melbourne Planning Scheme and is subject to Schedule 2 of the Environmental Significance Overlay (ESO2) Exceptional Trees. Specifically the 74 English Elm (*Ulmus procera*) along Queens Walk (Group 11 (G11): Ulmus procera, Yarra Park Brunton Avenue, East Melbourne). The River Red Gum (*Eucalyptus camaldulensis*) which is a living Scarred tree with Aboriginal significance. The location of the trees covered by ESO2 can be seen in Figure 3.

Figure 3 – shows the 74 trees in Queens Walk (ETR register No 175) and the Scar Tree (ETR tree 176).

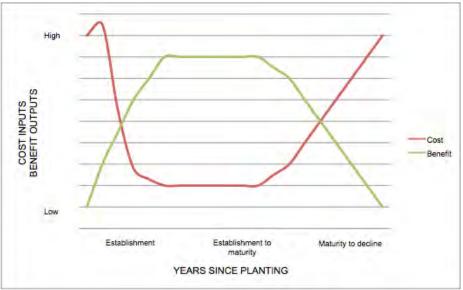
All avenues and stands of trees have a finite lifespan and at some point, trees need to be removed and replaced. As trees age, they require increasing management to maintain them in a safe and attractive condition. Hitchmough (1994) suggests that the aesthetic return of a tree in the landscape increases as it ages. It reaches a plateau for a period and then begins to fall away as a tree enters its decline phase. Conversely to this management costs increase as a tree ages as it requires more arboricultural input to maintain it in a safe, attractive manner (See Figure 4).

Figure 4. Relationship between time since planting and the aesthetic returns and management costs generated by a tree (from Hitchmough, 1994).

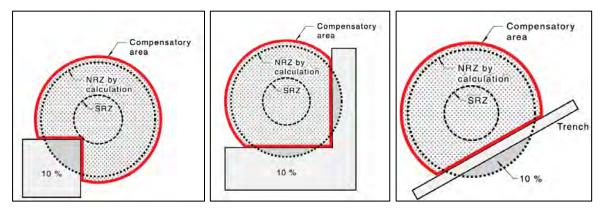
Encroachment into the NRZ is permissible under certain circumstances though is dependent on both site conditions and tree characteristics. Minor encroachment, up to 10% of the NRZ area, is generally permissible. Ideally, this loss of area should be compensated for by recruitment of an equal area contiguous with the NRZ. The 10% encroachment on one side only equates to a reduction of approximately ½ radial distance. Examples are provided in Figure 5. Encroachment greater than 10% is considered Moderate or Major encroachment under AS4970-2025 and is only permissible if it can be demonstrated that after such encroachment the tree would remain viable.

Figure 5. Examples of minor encroachment into a NRZ. Extract from: AS4970-2025, p13

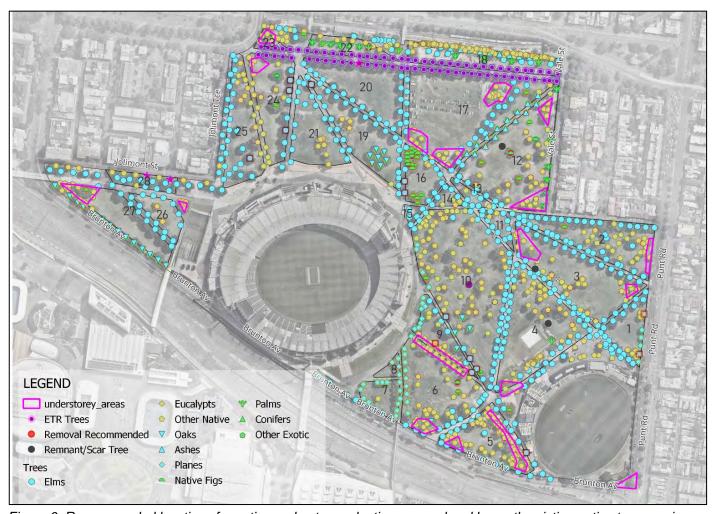
Figure 6. Recommended locations for native understorey plantings around and beneath existing native tree specimens.

- Native grasses, tussocks and rushes such as *Dianella* spp, *Lomandra* spp, *Poa*, spp. *Stipa* and *Themedia* spp.
- Groundcovers such as Atriplex spp, Brachiscome spp, Goodenia spp, Helichrysum spp,
- Shrubs such as Allocasuarina littoralis, Acacia acinacea, Acacia myrtifolia, Bursaria spinulosa, Banksia spinosa, Banksia marginata, Olearia spp. Pomaderris racemosa, Pultanaea spp.

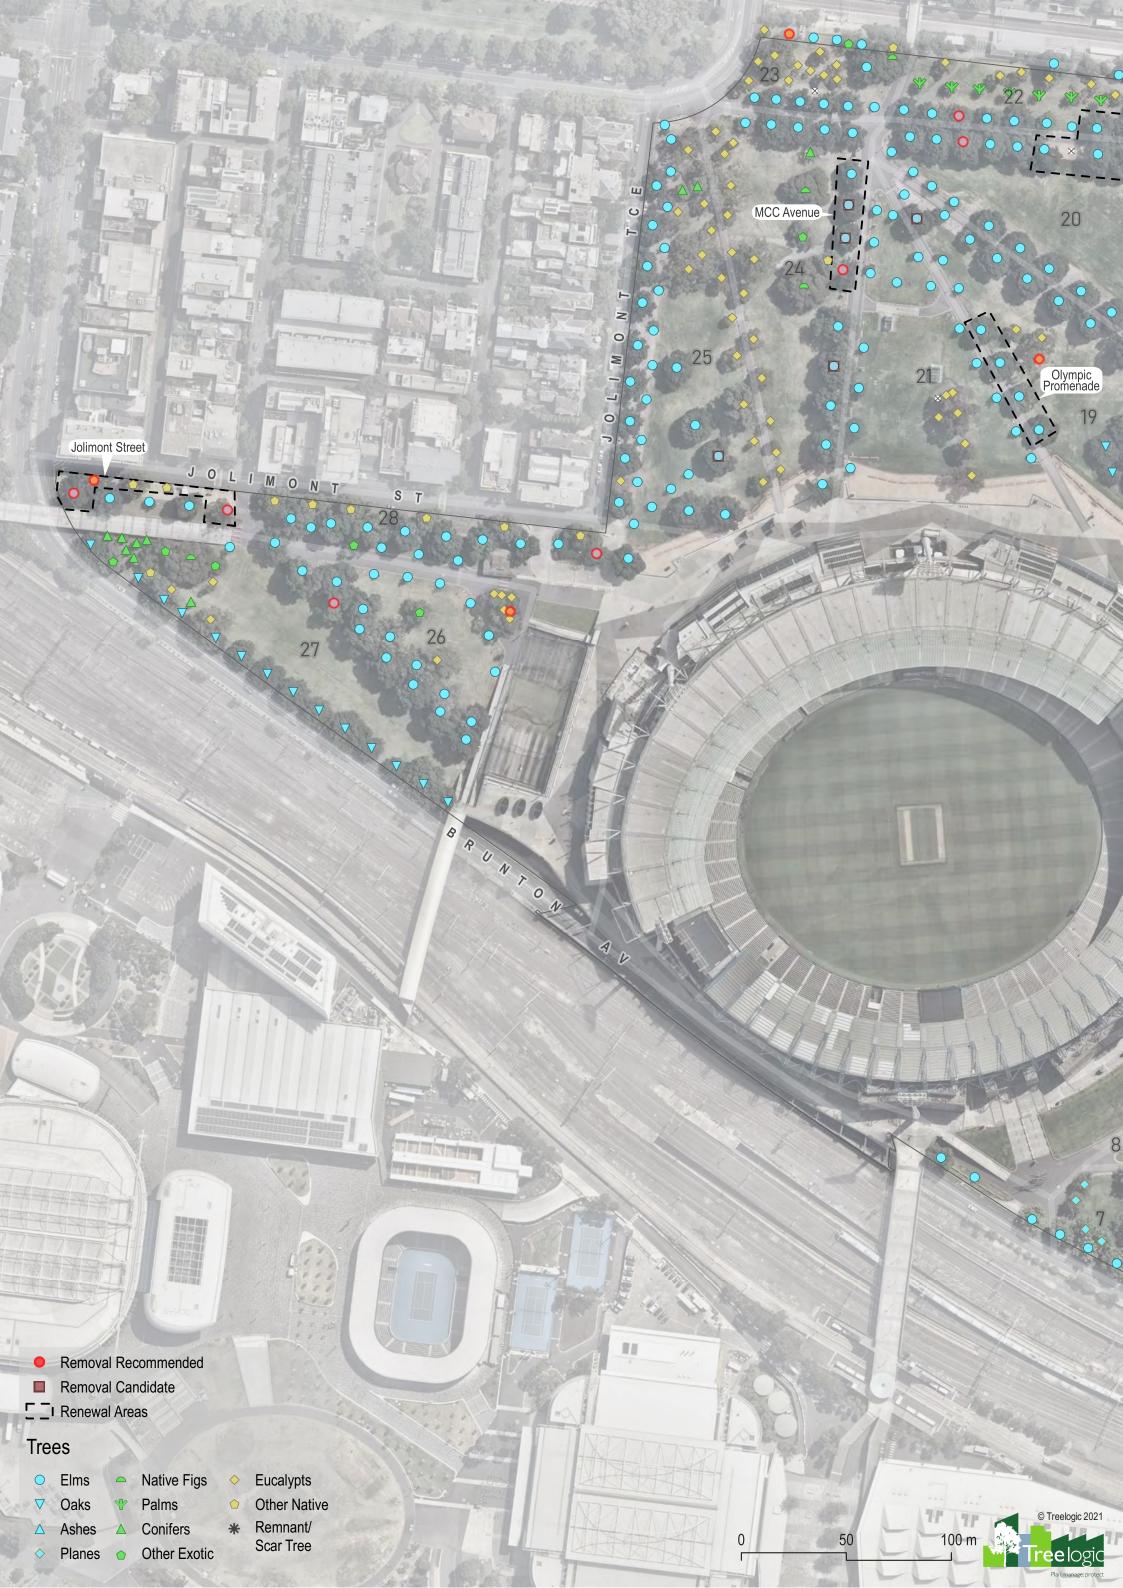
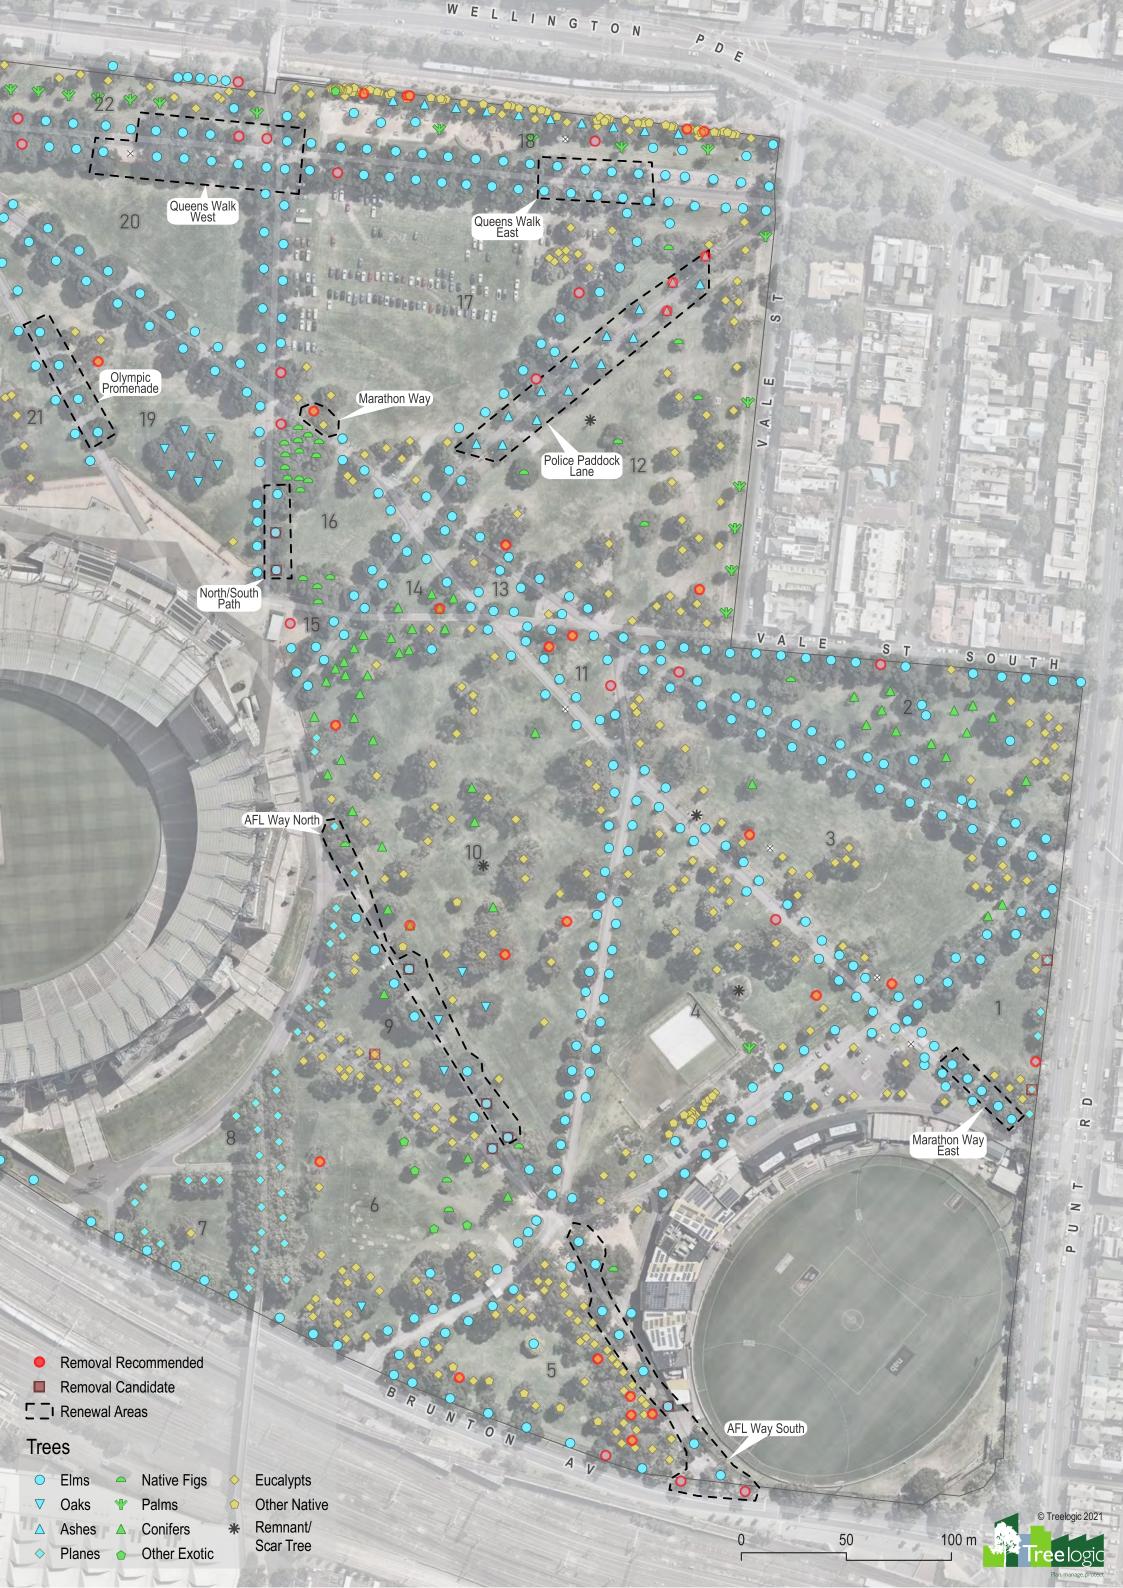
APPENDIX 1 – Proposed tree avenue renewal works.

This report proposes sections of treed avenues for renewal. Recommendations for renewal sections are based on deteriorating tree condition (health and/or structure), or to reinforce already existing renewal programs. There are no specific timeframes listed for initiating the tree avenue renewal works.
